Chapter 3

THE ACCOUNT OF WORLD TRADE CENTER 2

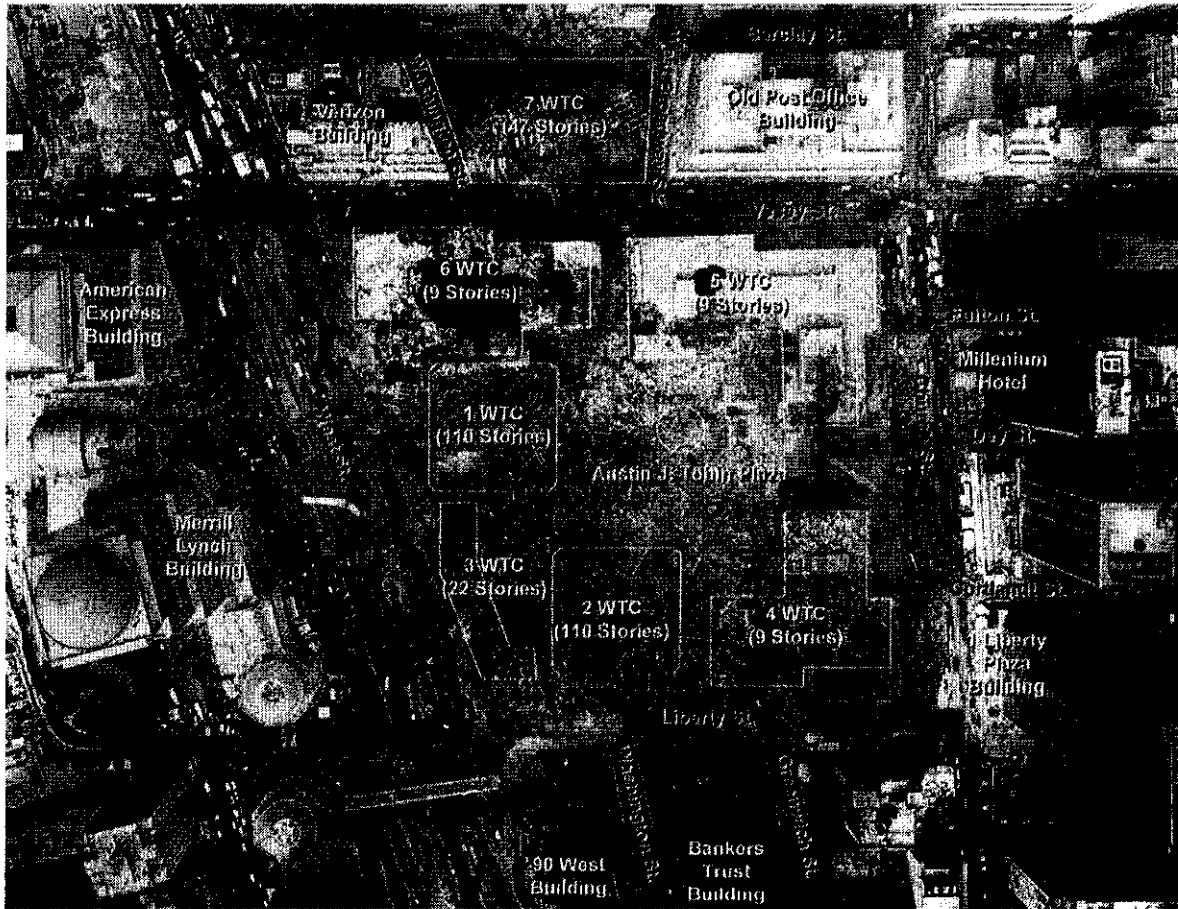
By sunset on September 11, 2001, all seven buildings on the World Trade Center (WTC) site lay in ruins (Figure 4-1). Table 4-1 compiles the likely locations of the decedents.

Figure 4-1. The WTC site on September 17, 2001.

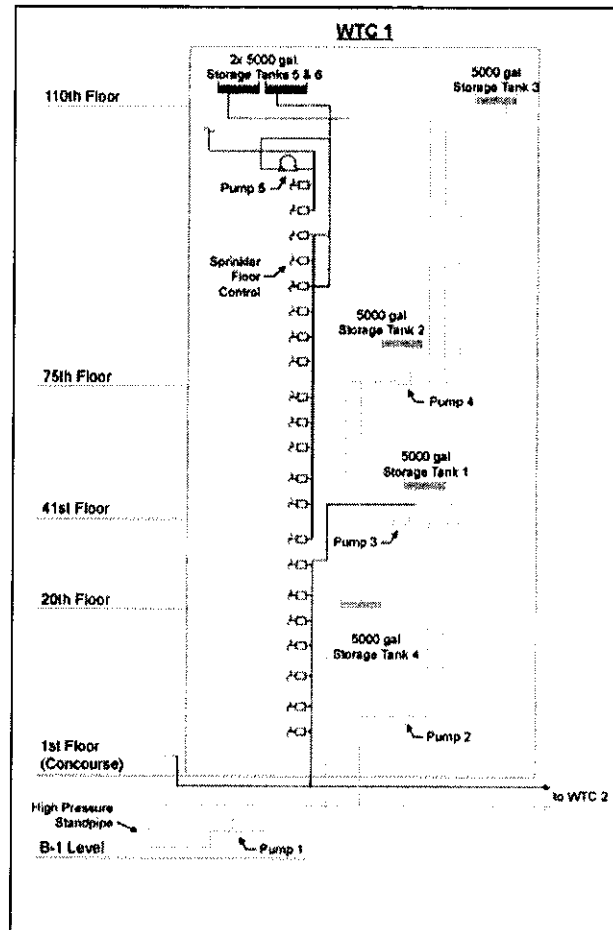
started pumps located in the towers; the FDNY could augment the supply using fire department connections and truck-based pumps. While there were redundant vertical supply pipes, there was only a single connection to the array of sprinklers on any given floor.

Figure 5-2. Schematic of sprinkler and standpipe systems.

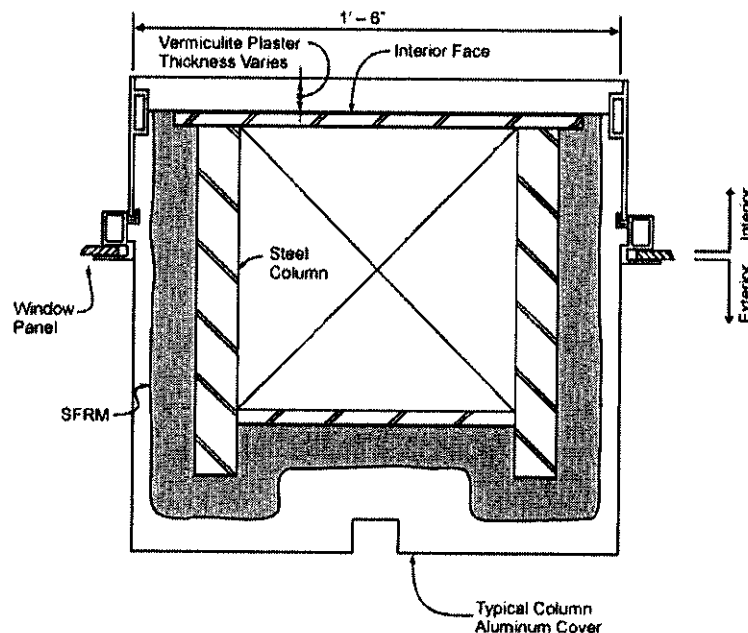
In 1966, the contractor responsible for insulating the perimeter columns proposed applying a 1 3/16 in. thick coating of BLAZE-SHIELD D to the three external faces (Figure 5–6) to achieve a 4 hour rating, which is a Class 1A rating requirement (1 hour more than Class 1B). NIST found evidence of a technical basis for this decision. In the construction drawings prepared by the exterior cladding contractor, the following SFRM thicknesses were specified:

- 7/8 in. of vermiculite plaster on the interior face and 1 3/16 in. of BLAZE-SHIELD D on the other three faces.
- 1/2 in. of vermiculite plaster on the interior surfaces of the spandrels and 1/2 in. of BLAZE-SHIELD D on the exterior surfaces.

Figure 5–6. Thermal insulation for perimeter columns.
